Asbestos Abatement Plan

**Doodle Trailhead Project
124 Railroad Street
Pickens, South Carolina**

May 1, 2017
Terracon Project No. 86177020

FORMER RAILROAD BUILDING
124 RAILROAD STREET
PICKENS, PICKENS COUNTY, SC

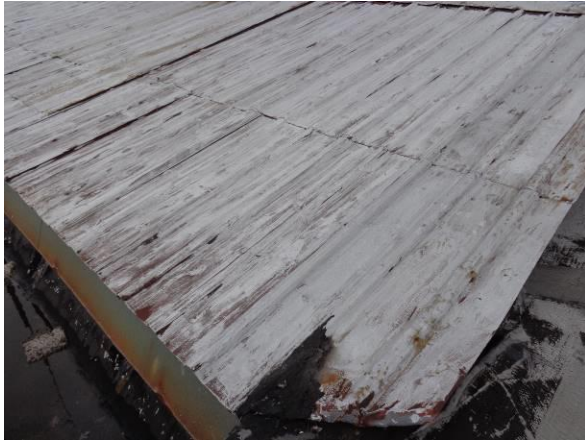
Photo #7 Silver paint and tar on metal roofing – contains asbestos.

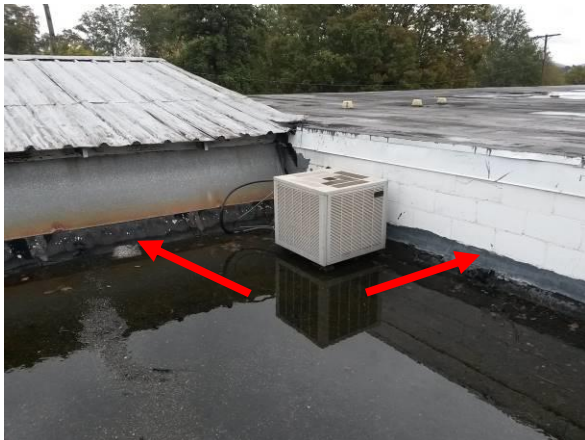
Photo #9 Flashing ("I") of Railroad Depot office building – contains asbestos

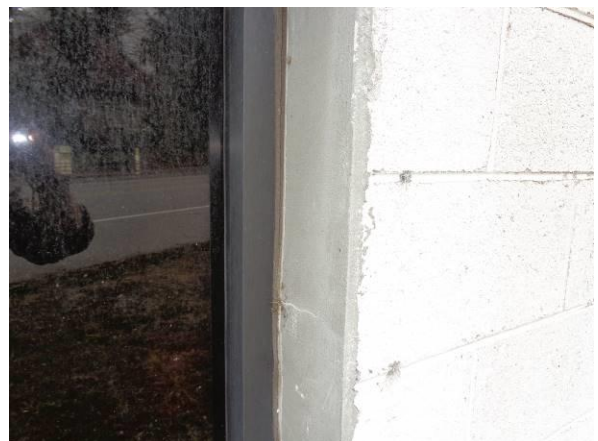
Photo #12 Brown/black caulk ("L"), on windows and doors of break room – contains asbestos

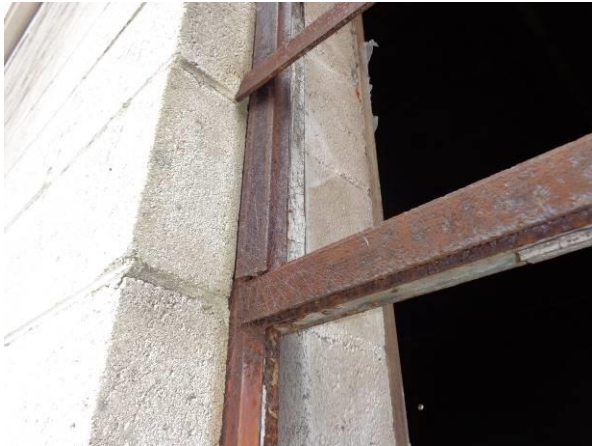
- F. Window glazing compound. All older metal framed windows have asbestos-containing glazing compound. Additionally the damaged glazing compound may have fallen into the CMU block. The entire window assembly may be removed and the CMU core shall be vacuumed to clean the debris. See Section 02081 for additional work practices.

Photo #13 Window glazing compound ("M") – contains asbestos

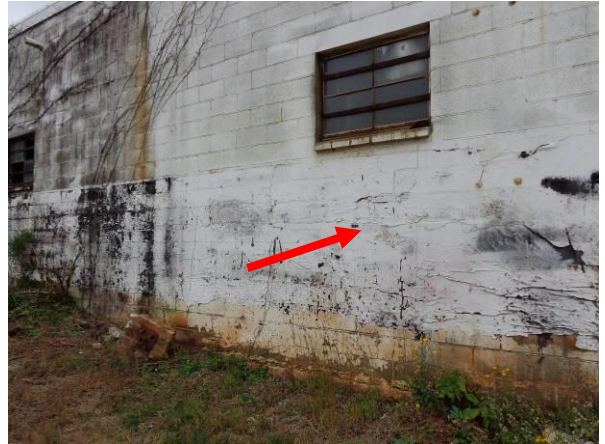
Photo #14 Felt and mastic ("N") on eastern building exterior – contains asbestos

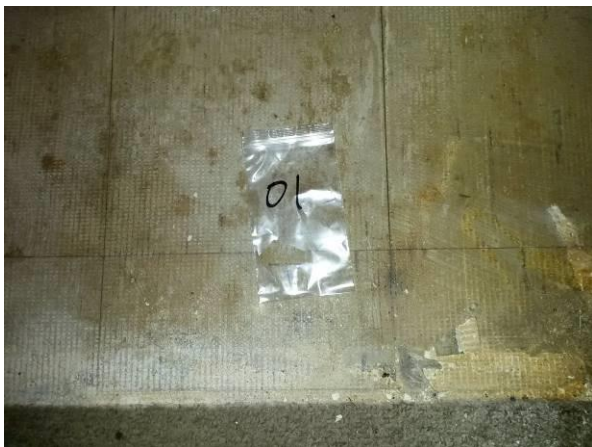
Photo #17 Tan 9-inch floor tile ("O") within office area – contains asbestos

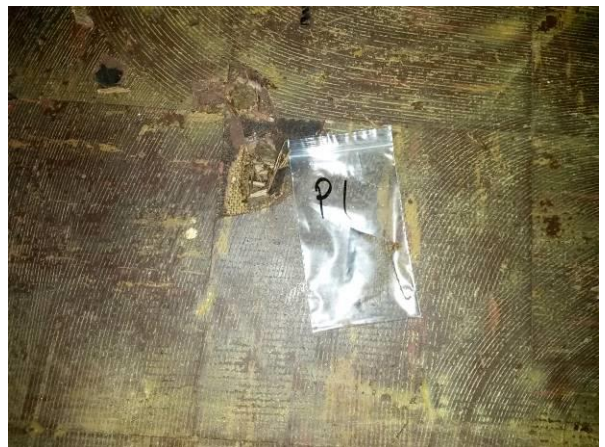
Photo #18 Brown 9-inch floor tile ("P") within office area – contains asbestos

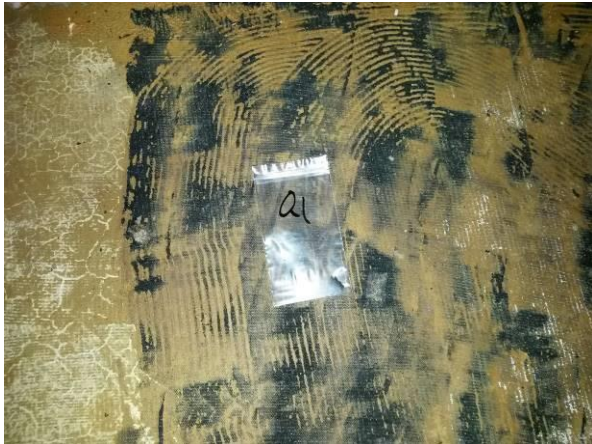
Photo #19 Black mastic ("Q") within office area
– contains <1% asbestos

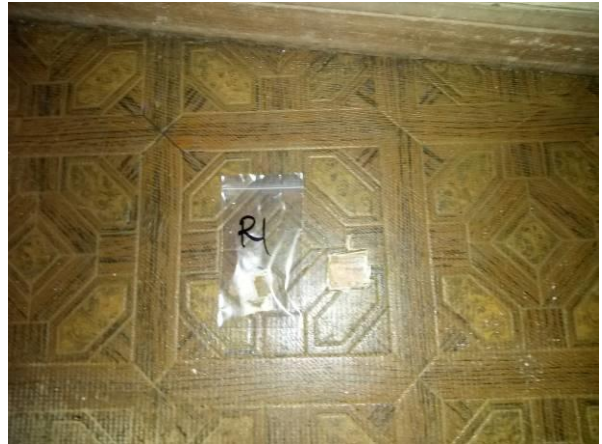
Photo #20 Brown sheet vinyl ("R") within office area
– contains asbestos

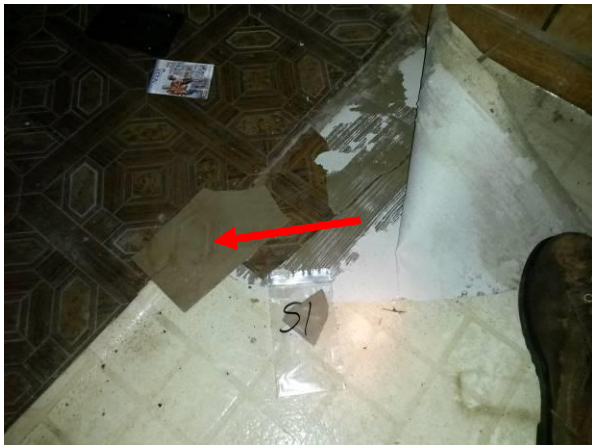
Photo #21 White sheet vinyl over brown floor tile ("S"), floor tile contains asbestos

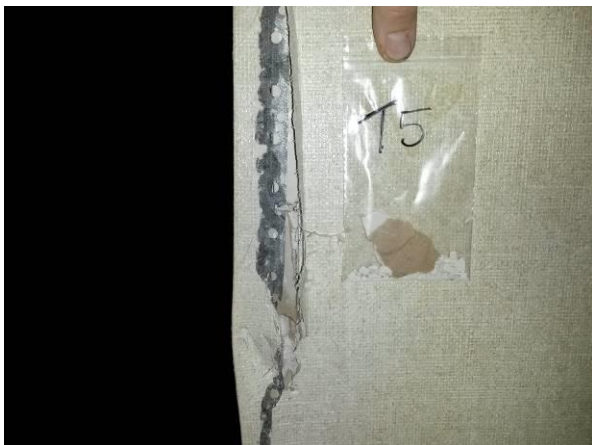
Photo #23 Drywall and joint compound ("T") –
joint compound contains asbestos

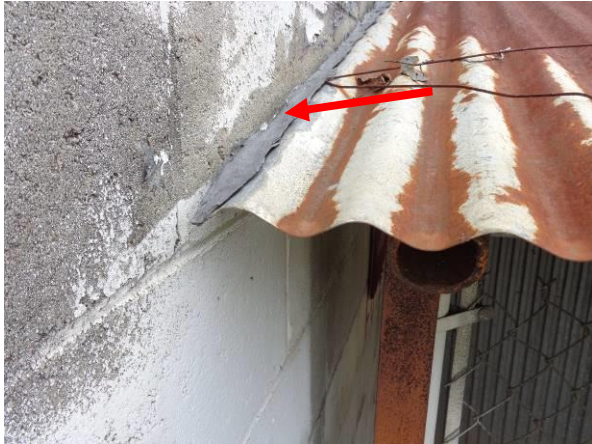
Photo #25 Flashing ("W") on metal roof of compressed gas storage area – contains asbestos

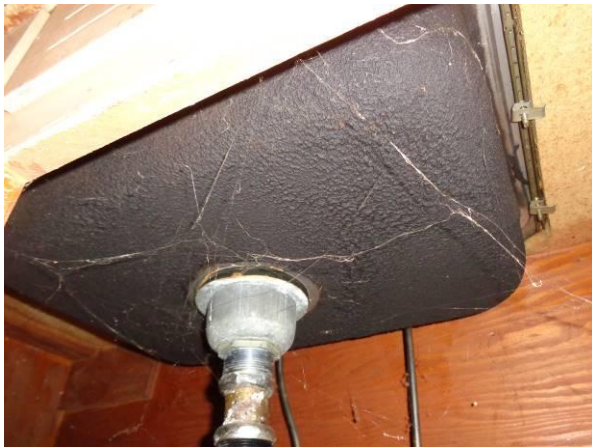
Photo #27 Sink coating ("Z") within break room area – contains asbestos

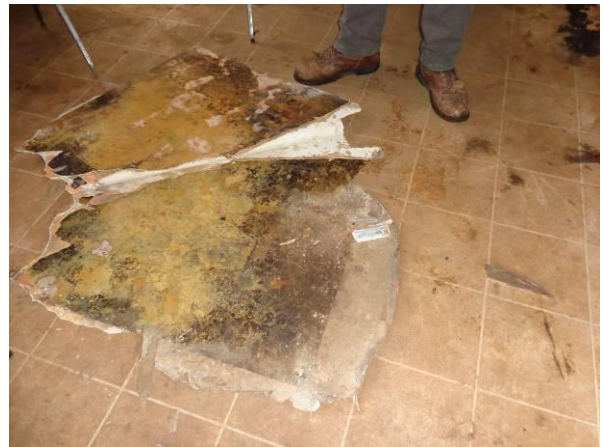
Photo #28 Light brown sheet vinyl ("AA") and yellow mastic ("AB") below plywood – yellow mastic contains <1% asbestos

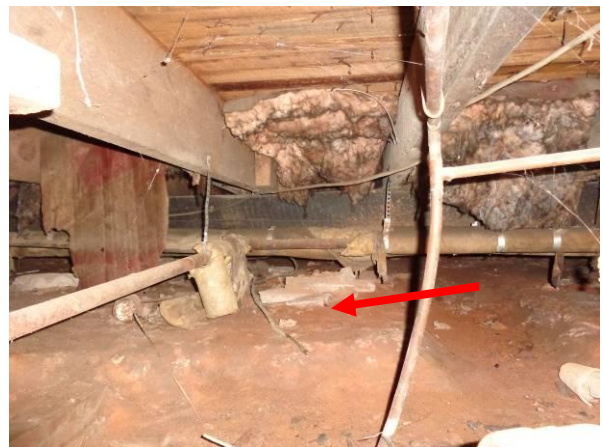
Photo #30 View of crawlspace below office area. Apparent TSI debris ("AG") assumed to contain asbestos
